TACHO Universal hand-held Device Repair Instructions

TU Repair Instructions

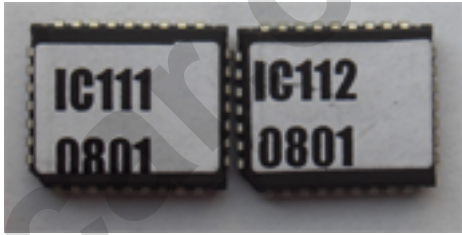
No.	Name	Quantity	Image	Remark
1	IC111 & IC112	2PCS

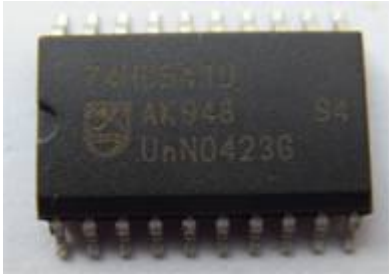
3	74HC541	1PC

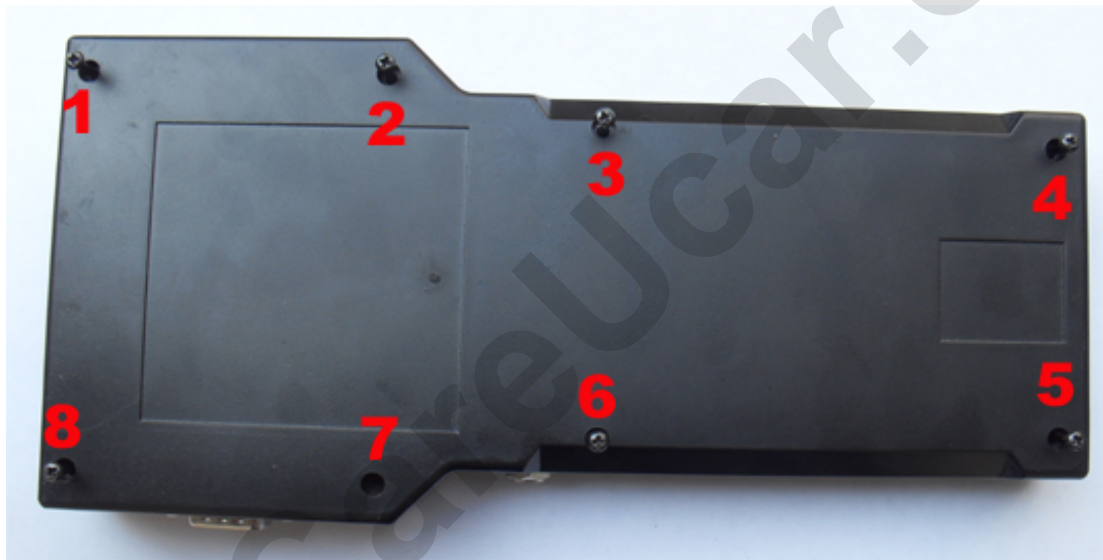
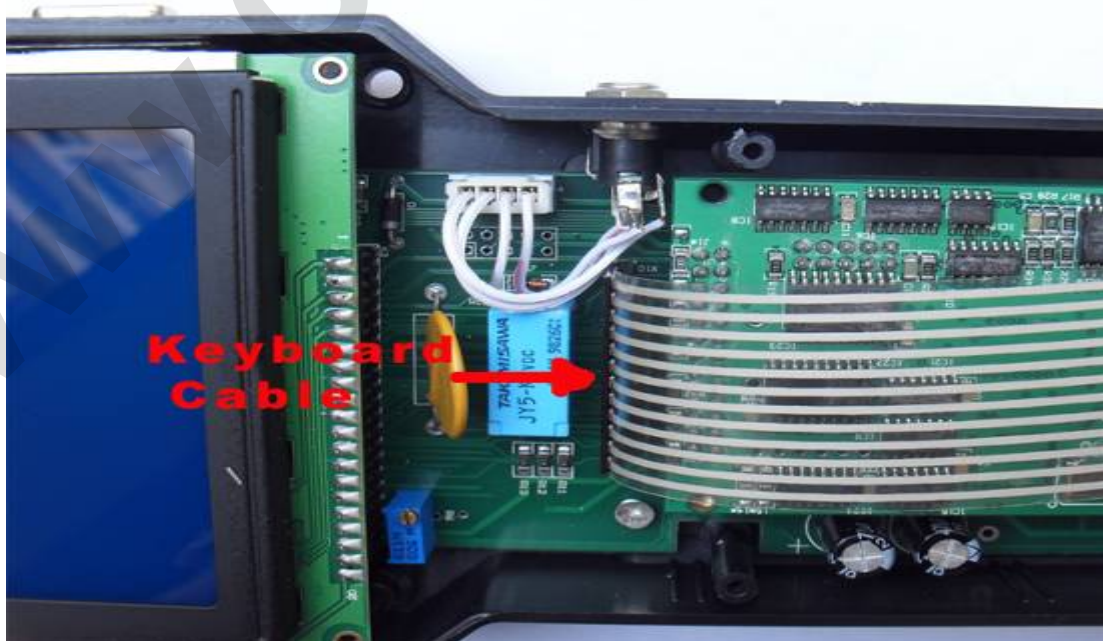
A. Remove the 8 screws, open the up cover, unplug the keyboard cable connector, and then remove the up cover as shown in the figure.

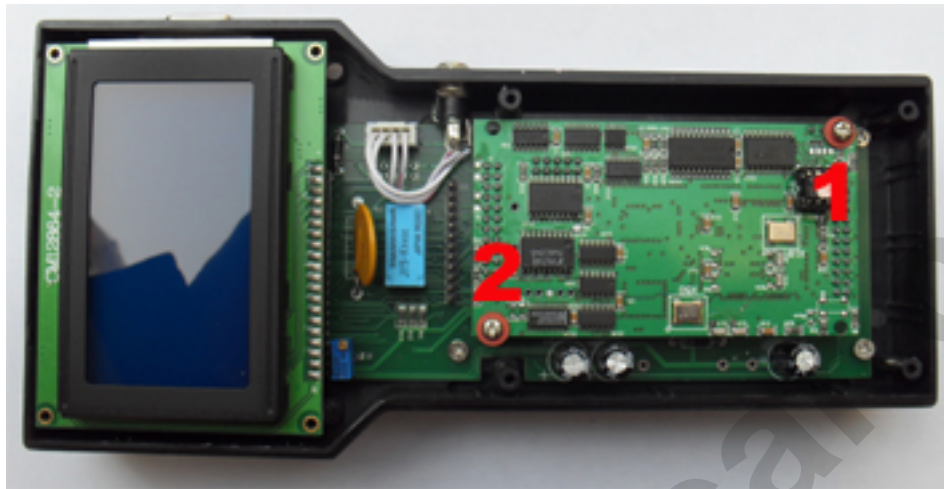
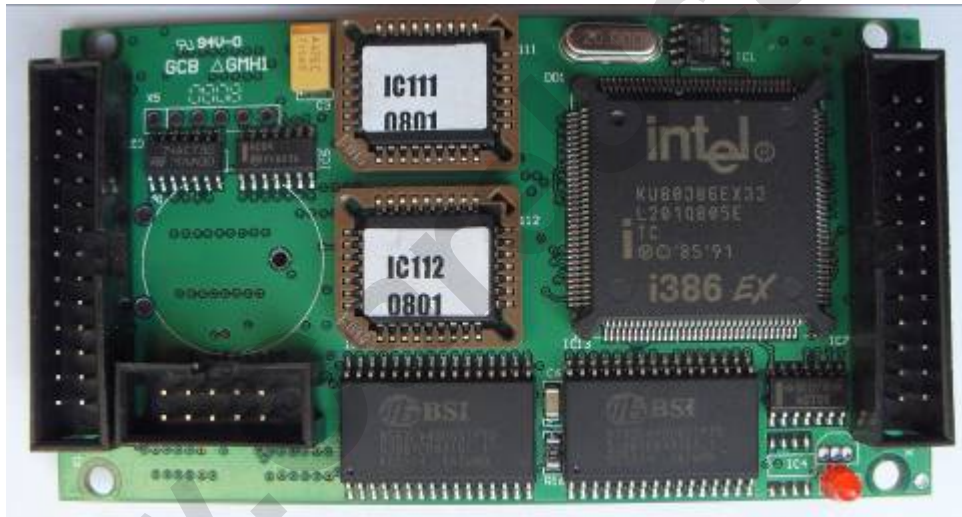
B. Remove the CPU BOARD as shown in the figure.

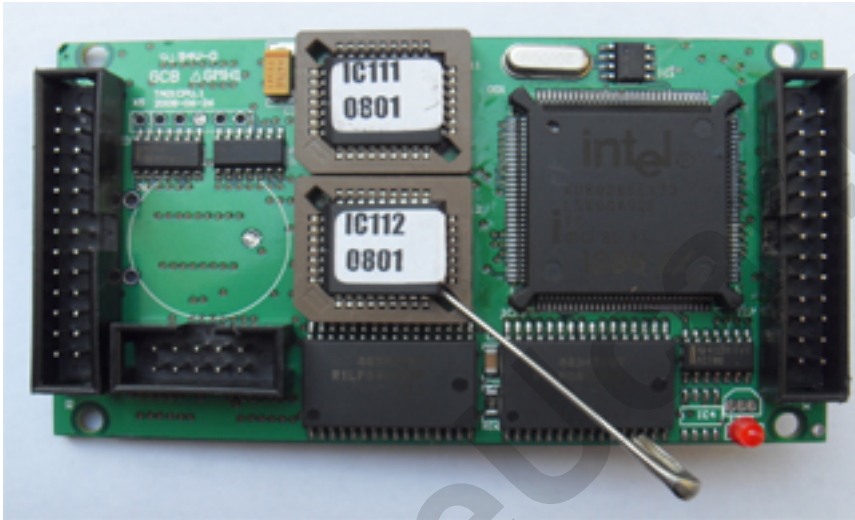
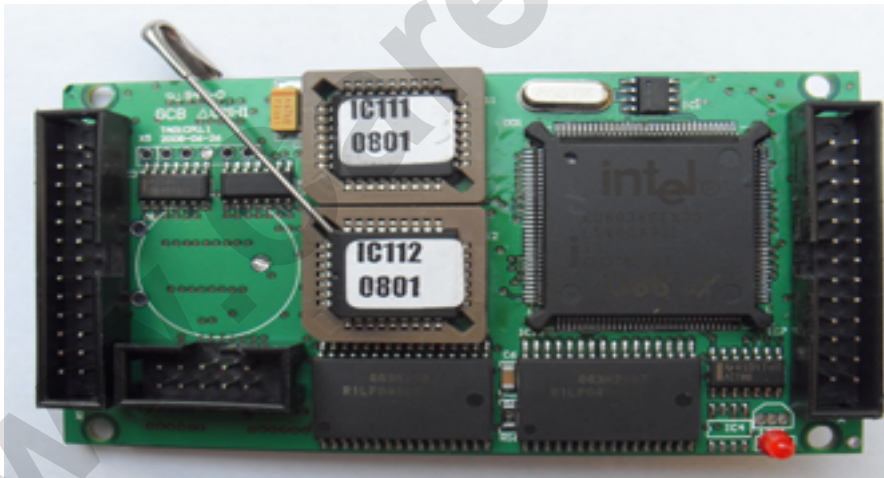
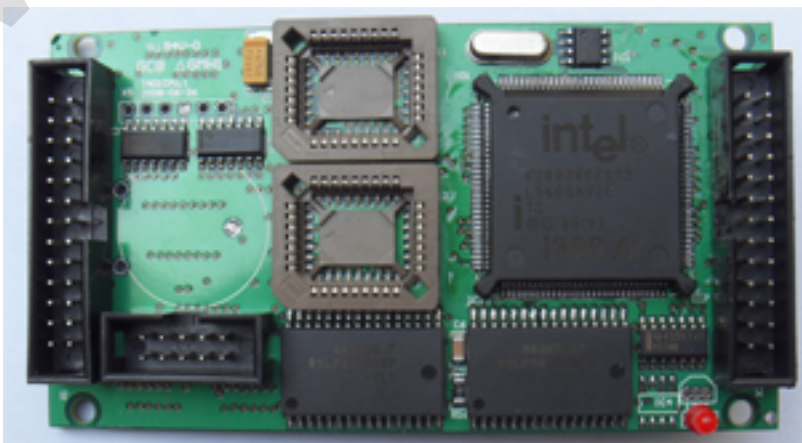
C. Remove IC111 and IC112 as shown in the figure.

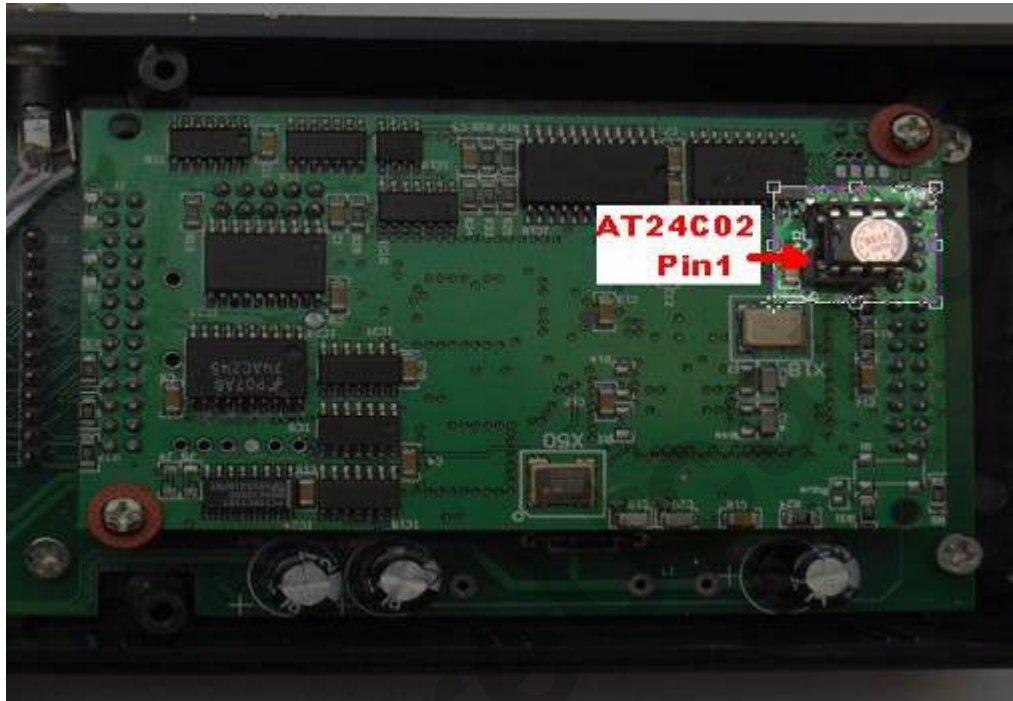
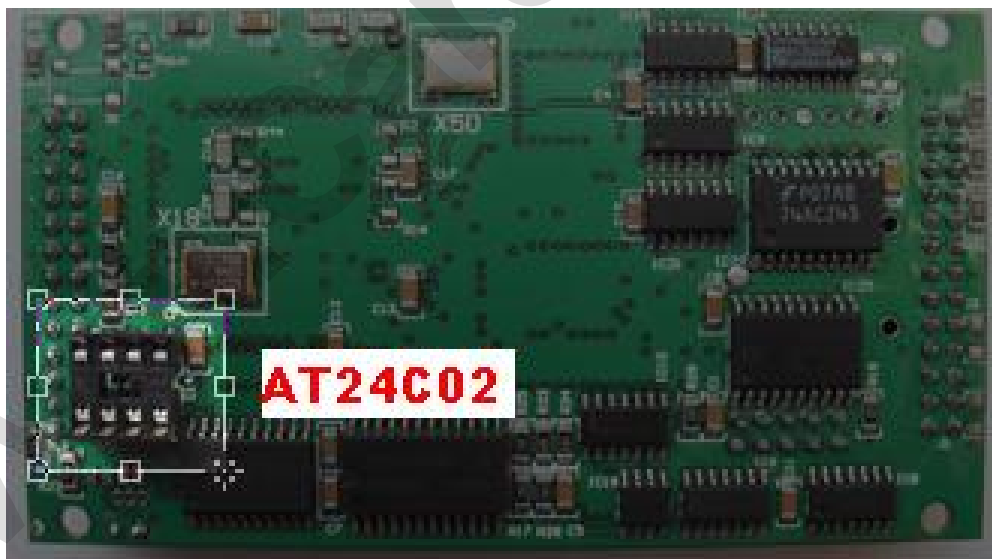
D. Remove AT24C02 as shown in the figure.

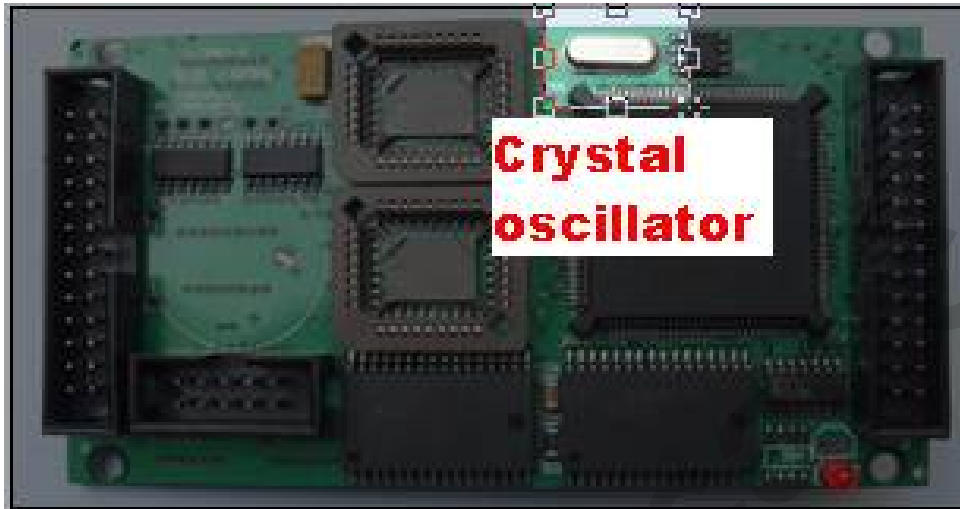
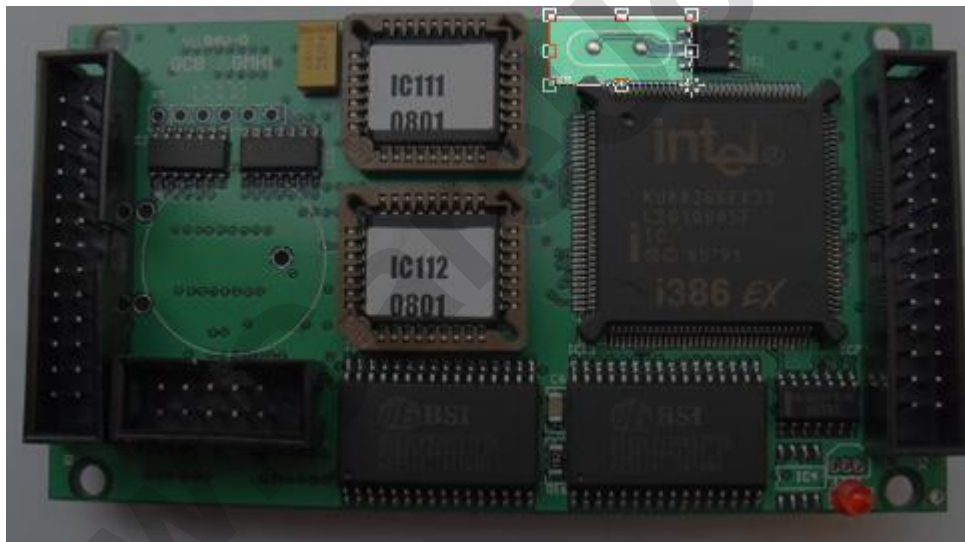
E. Remove Crystal oscillators as shown in the figure.

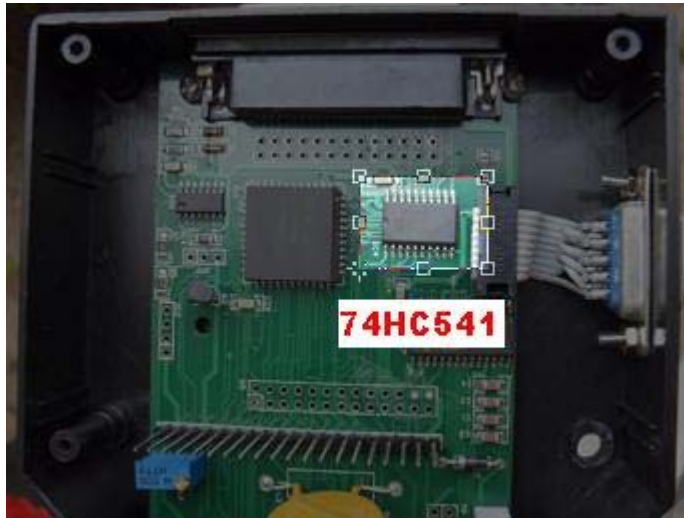
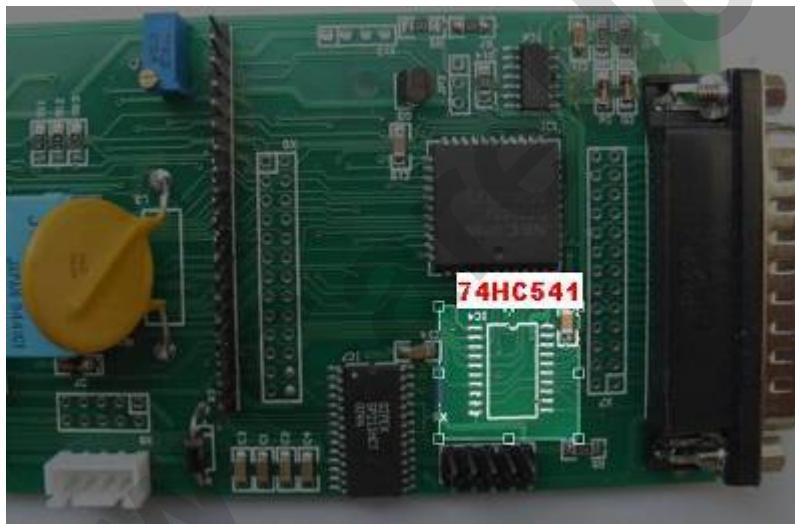
F. Remove 74HC541 and LCD as shown in the figure.

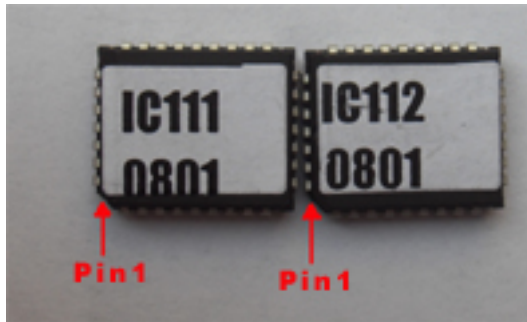
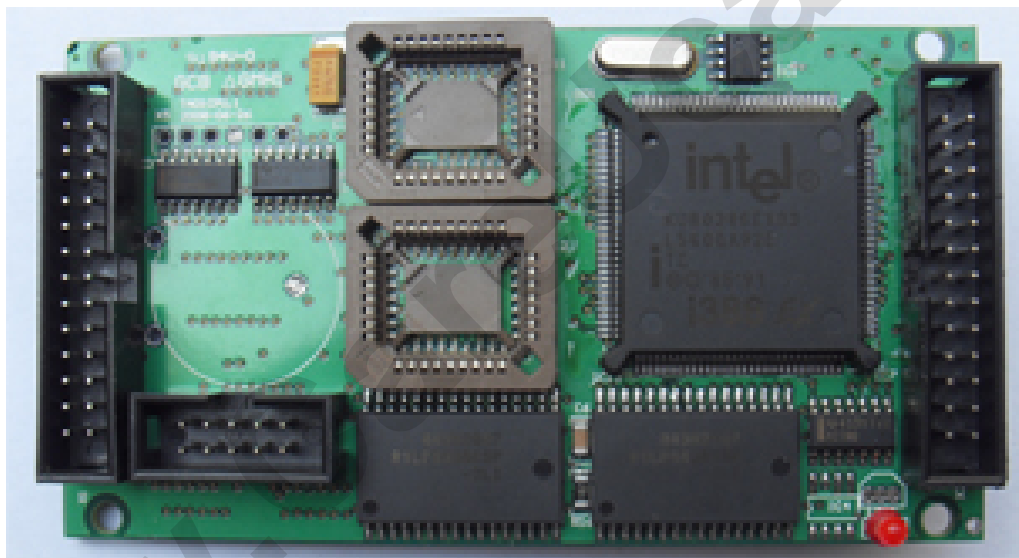
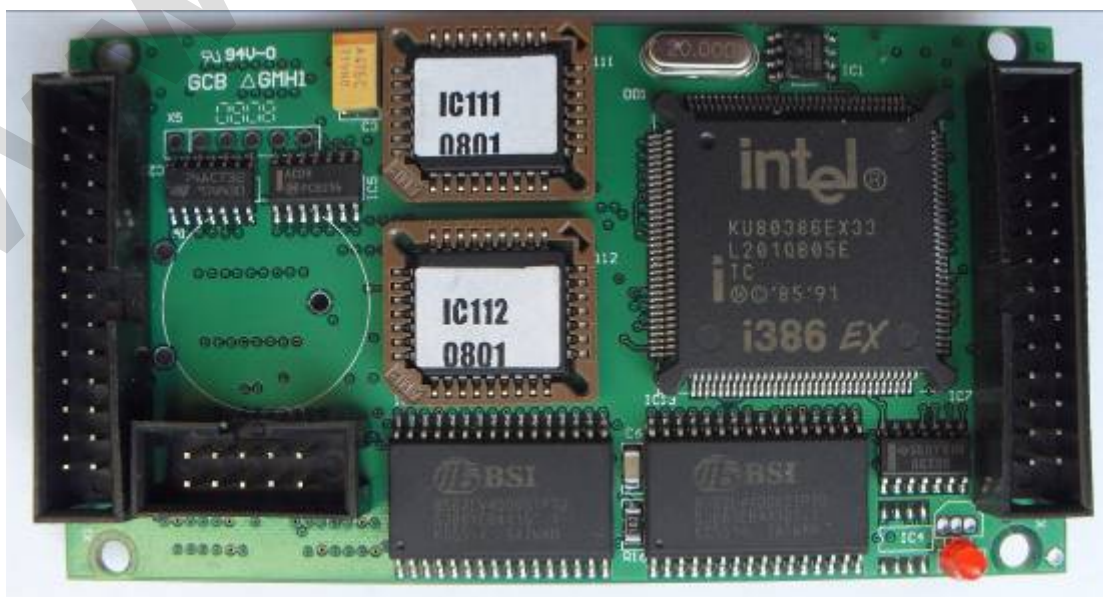
G. Install IC111 and IC112. Make sure the install direction is correct. See the figure.

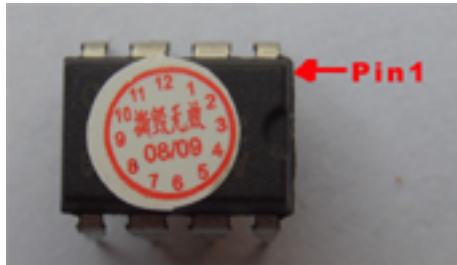
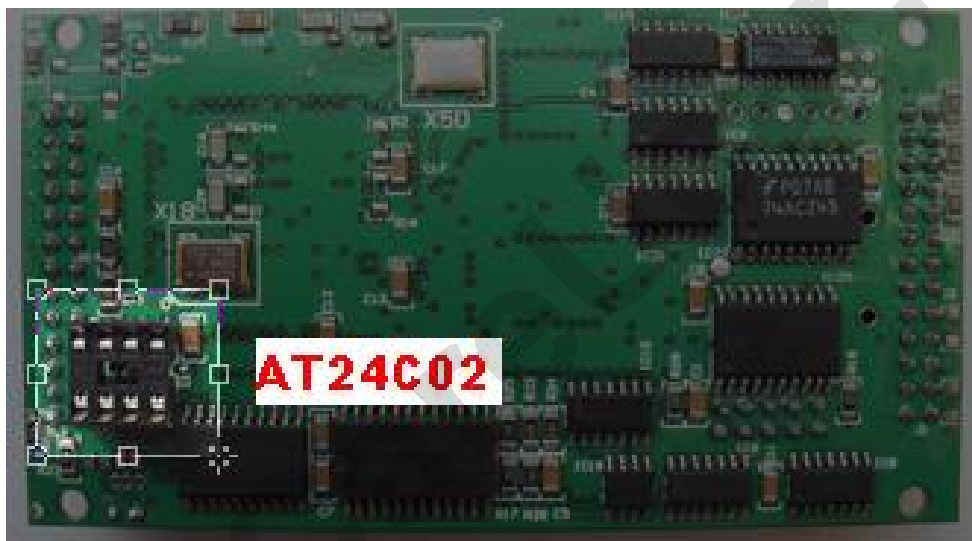
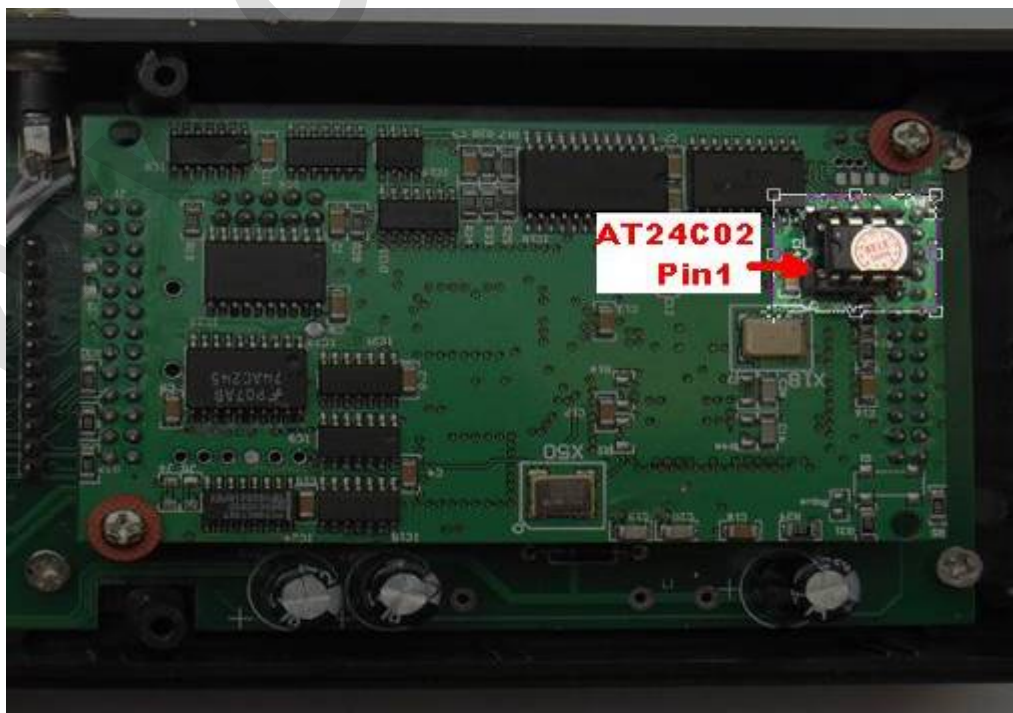
**H. Install AT20C02. Make sure the install direction is correct.
See the figure.**

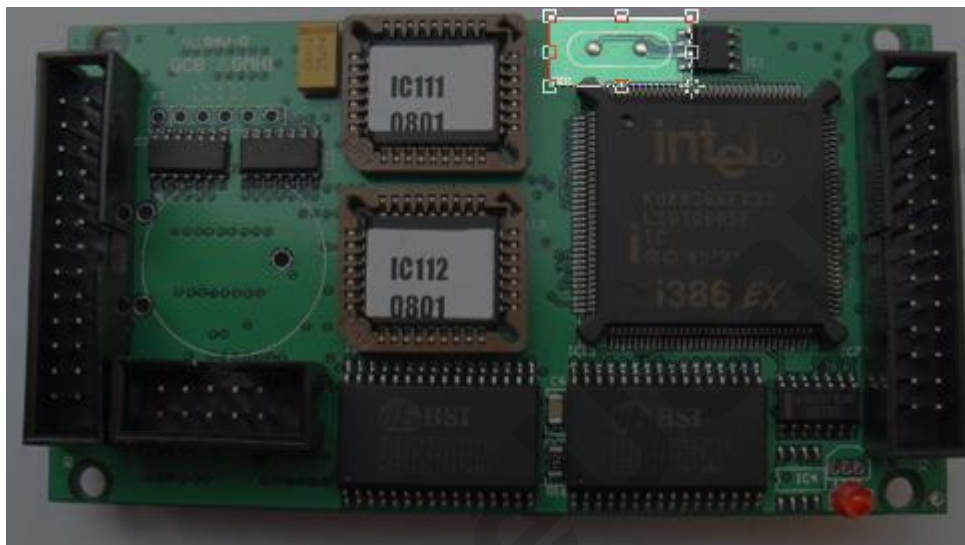
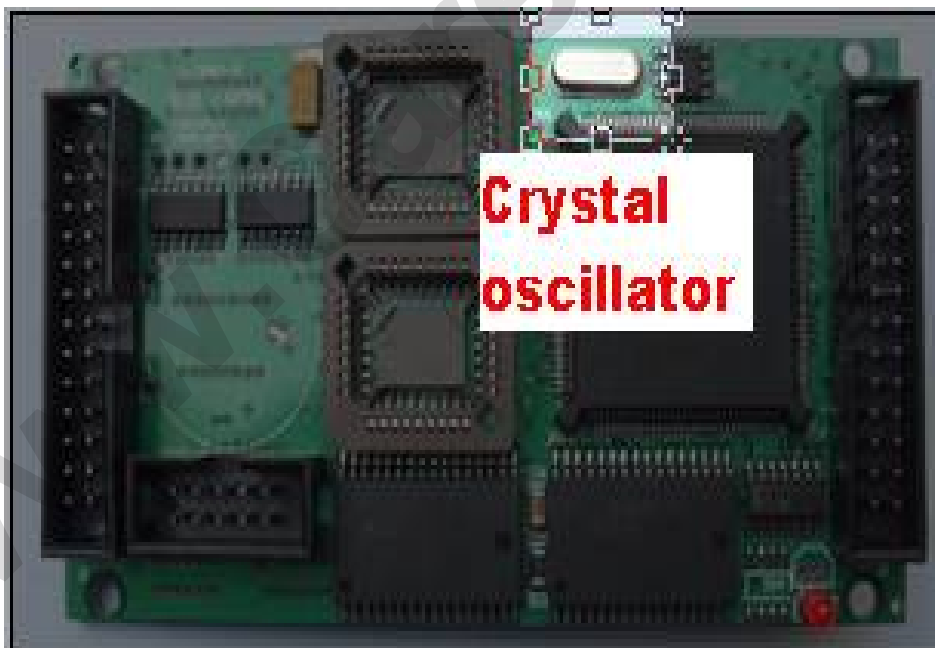
I. Install Crystal oscillator. See the figure.

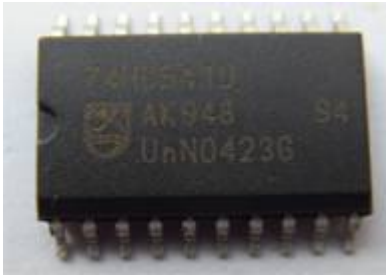
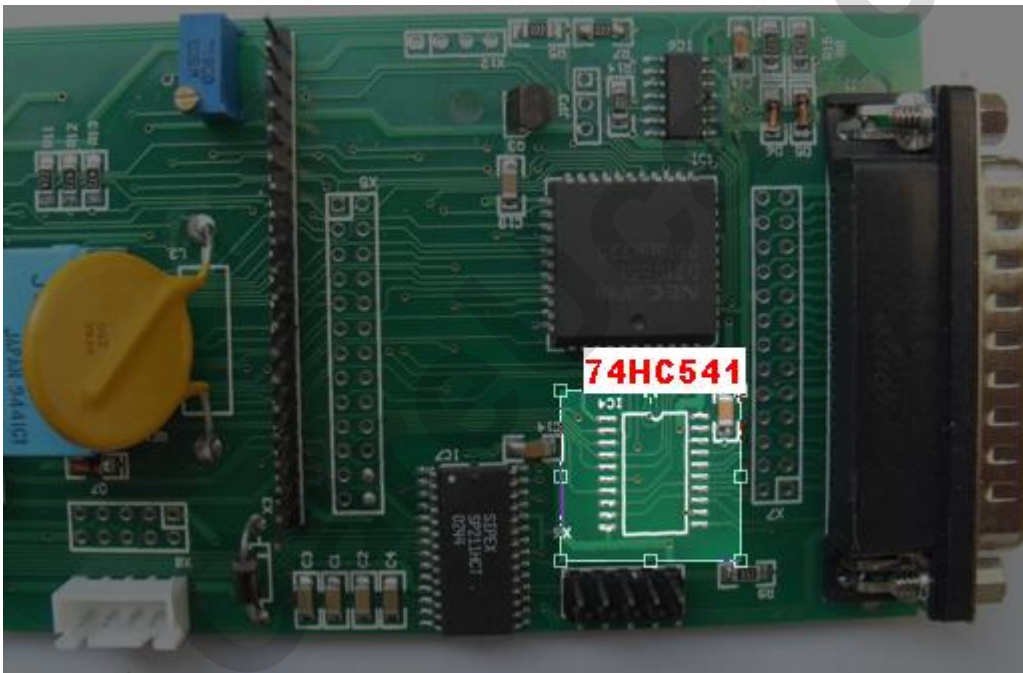
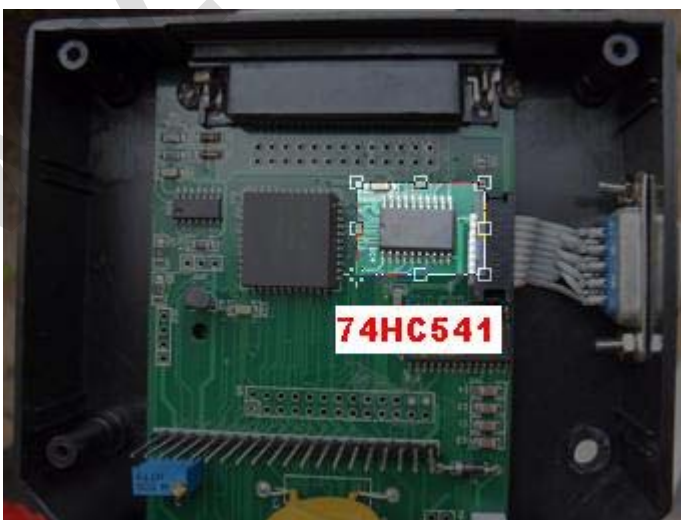
J. Install 74HC541, then the LCD. See the figure.

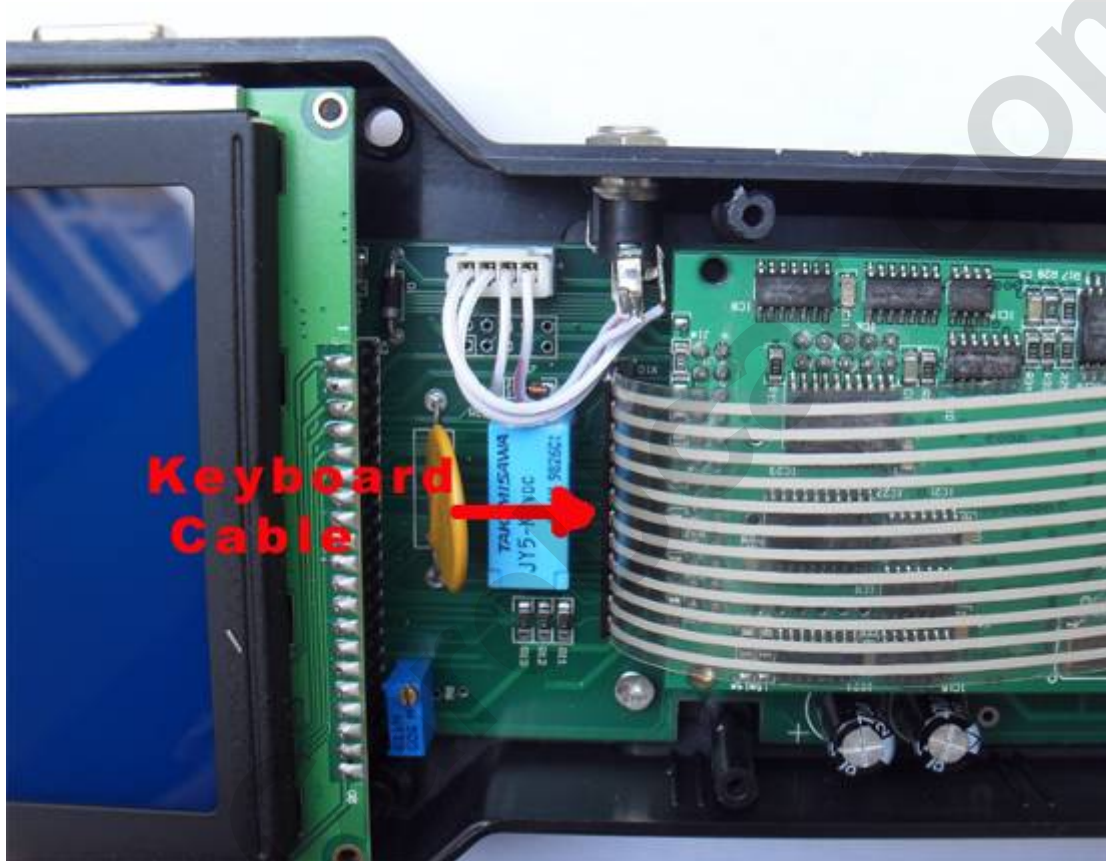
K. Install CPU BOARD. Make sure install it in correct direction.

See the figure.

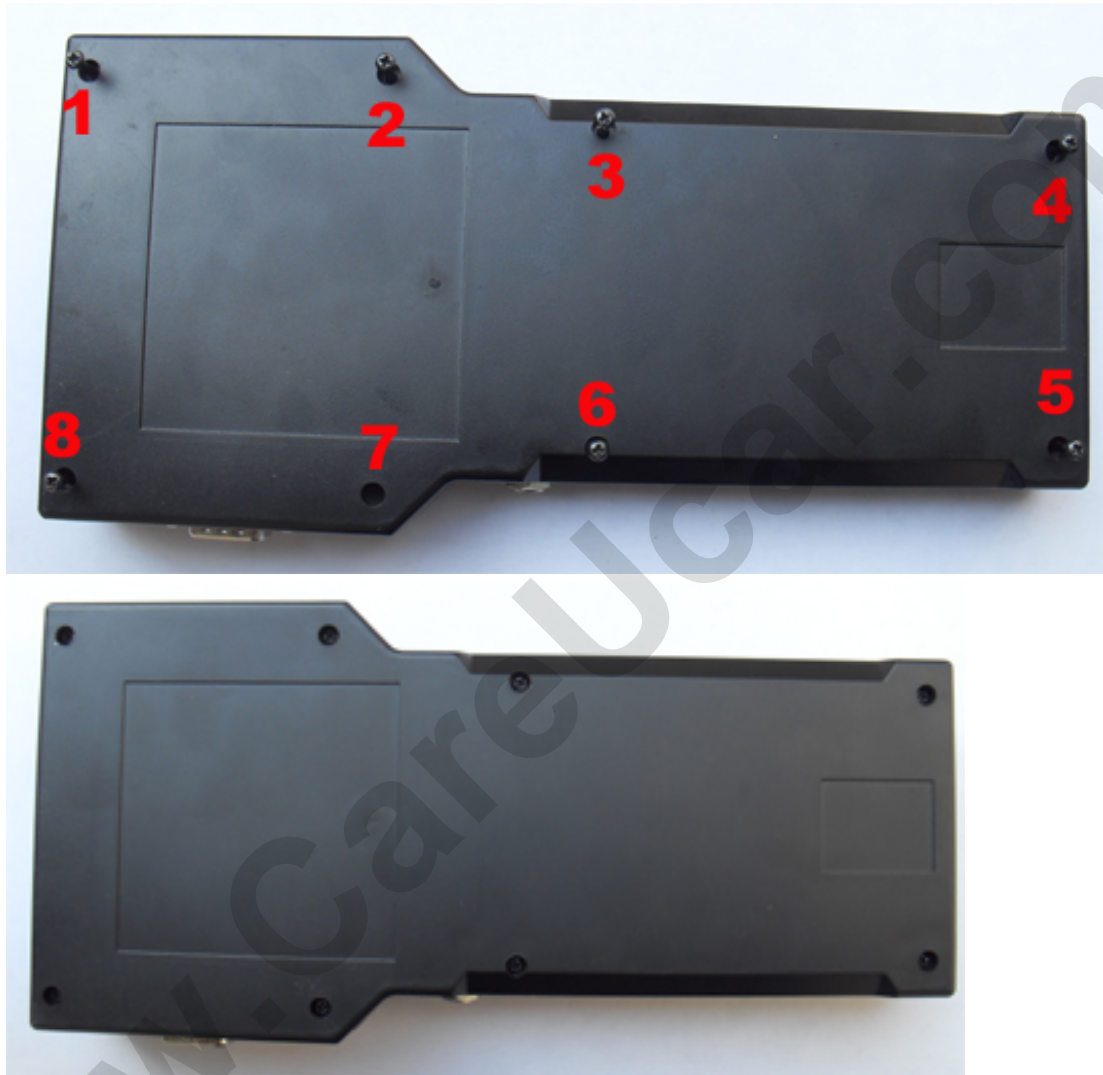
L. Install the up cover and then the 8 screws. See the figure.

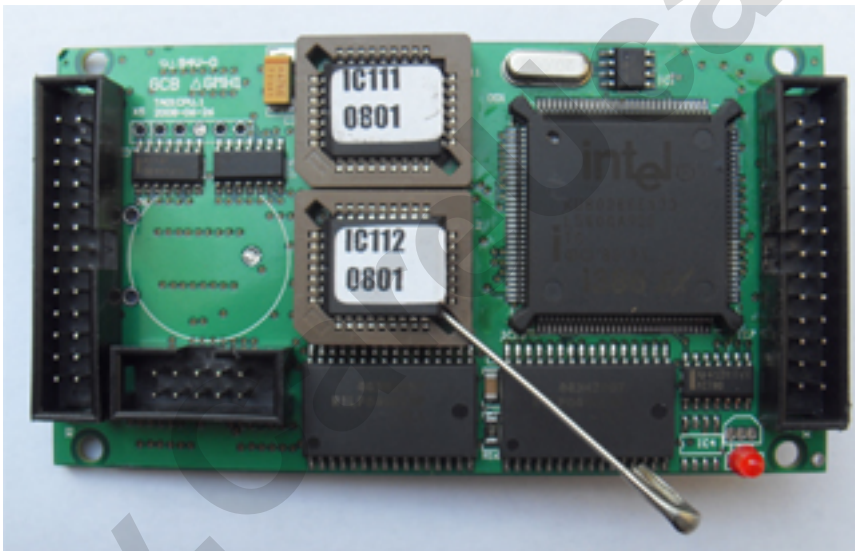
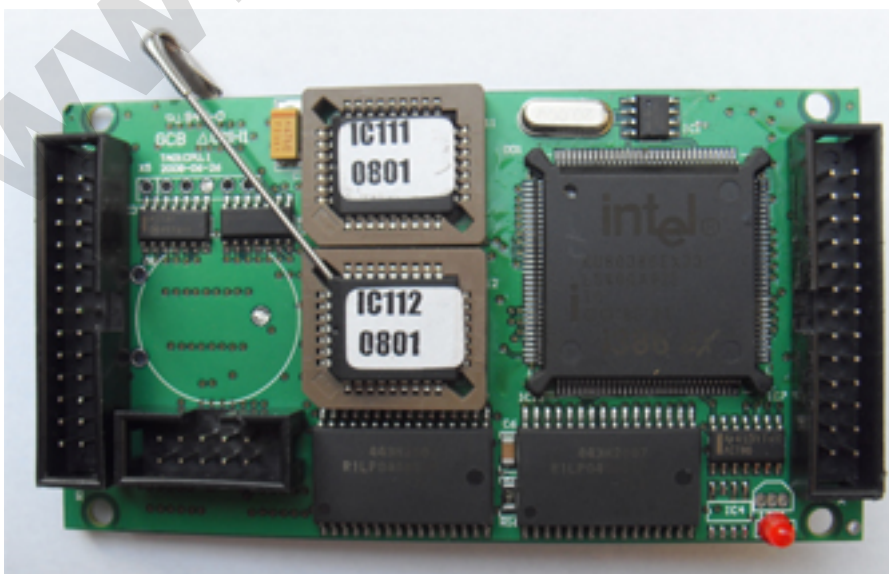
- A. Please use the special tool when removing or installing 74HC541 and Crystal oscillator.
- B. Remove IC111 and IC112 carefully by using the following tool.
